St. Joseph School  
Bathrooms  
September 2011

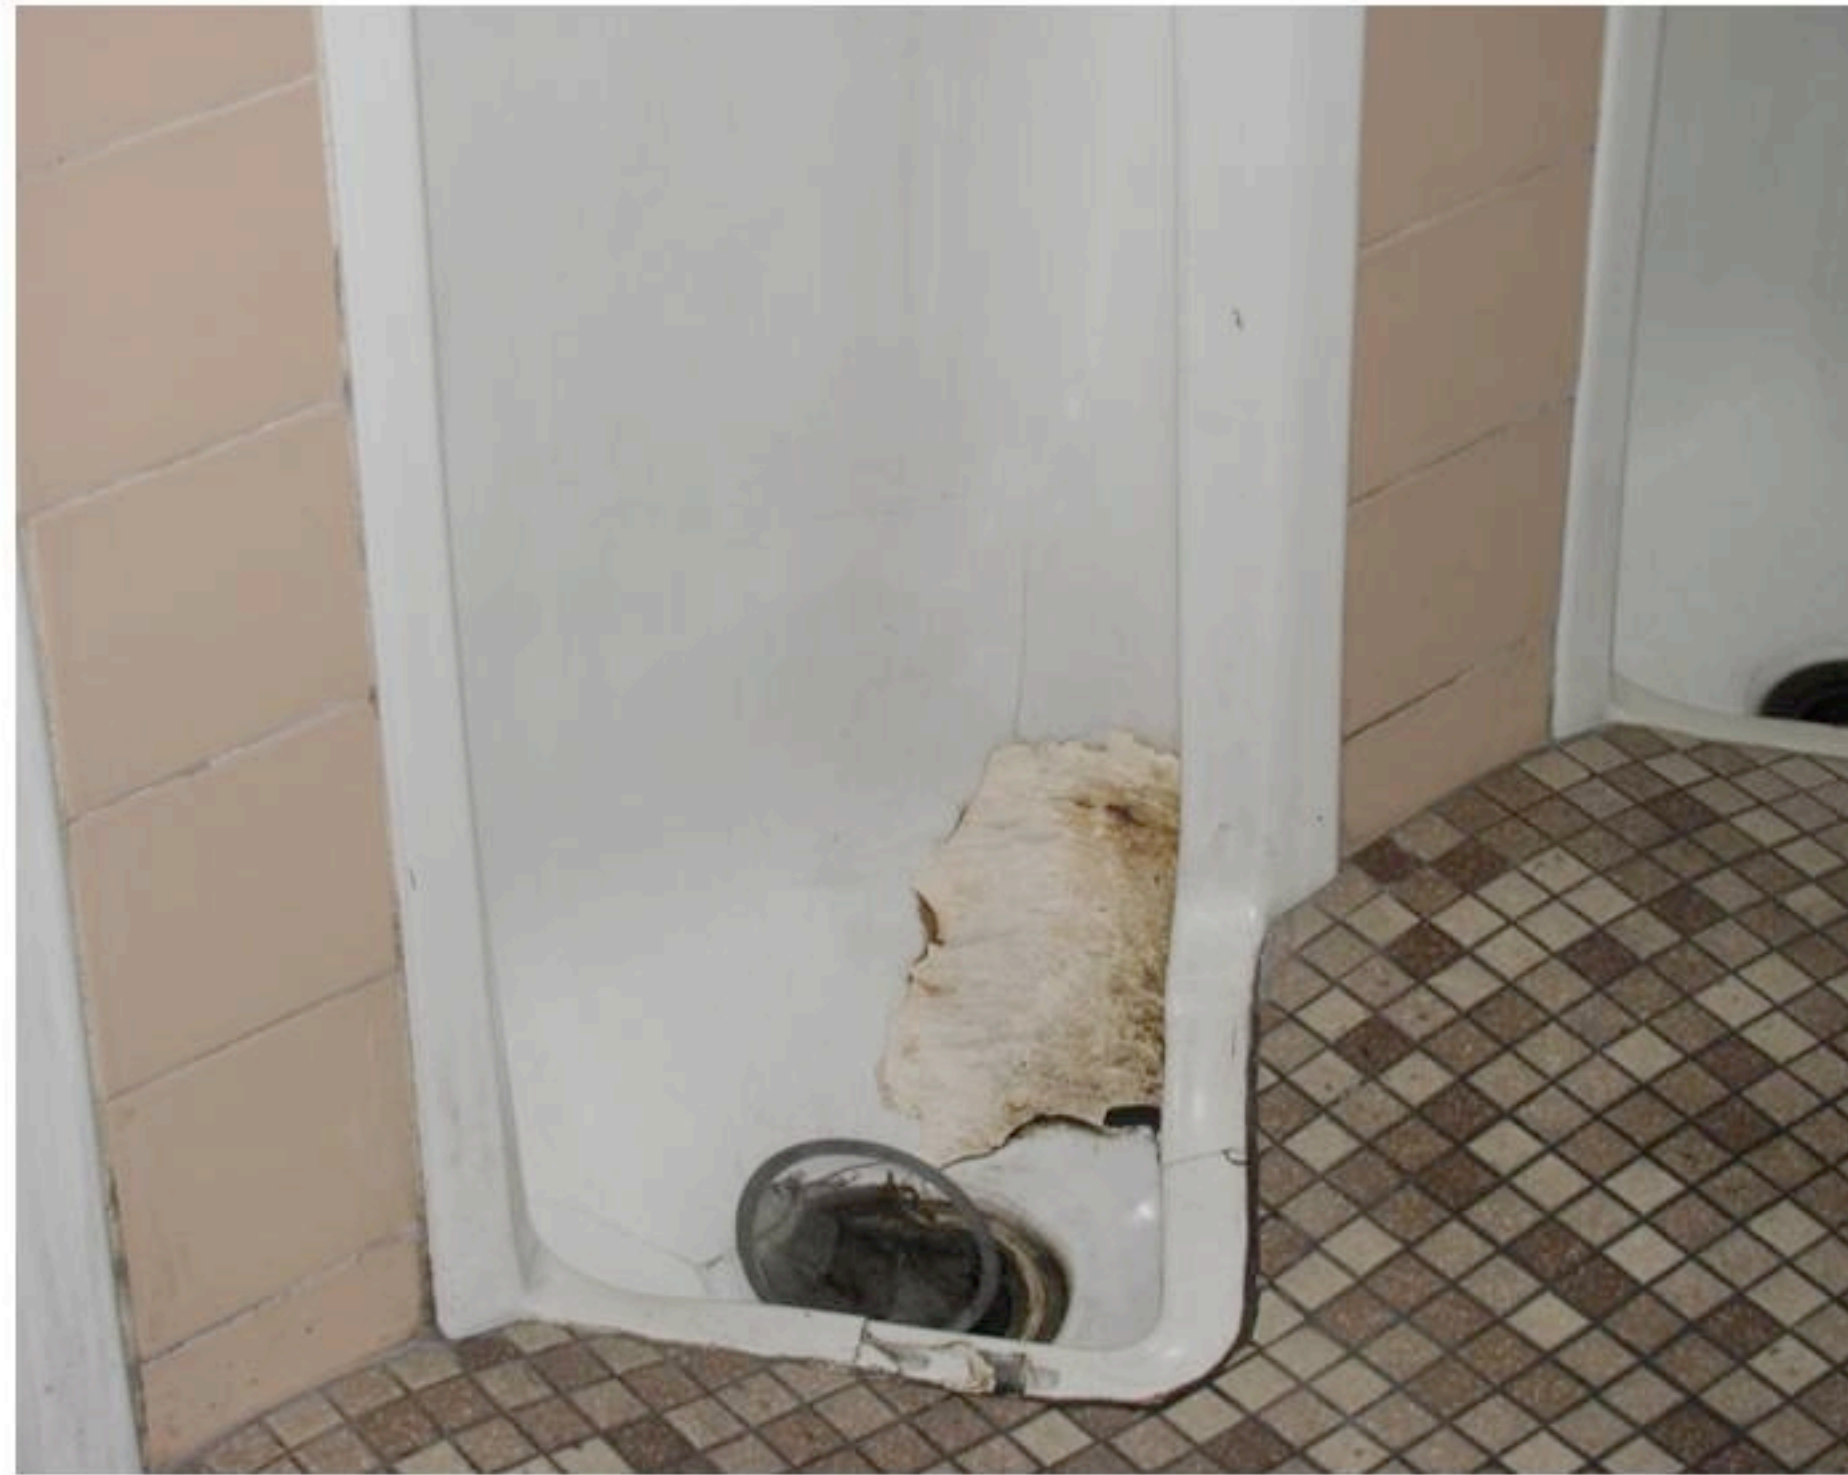
Urinal in Boys Restroom. Deteriorated patch job traps odors and therefore emits a constant unpleasant smell.

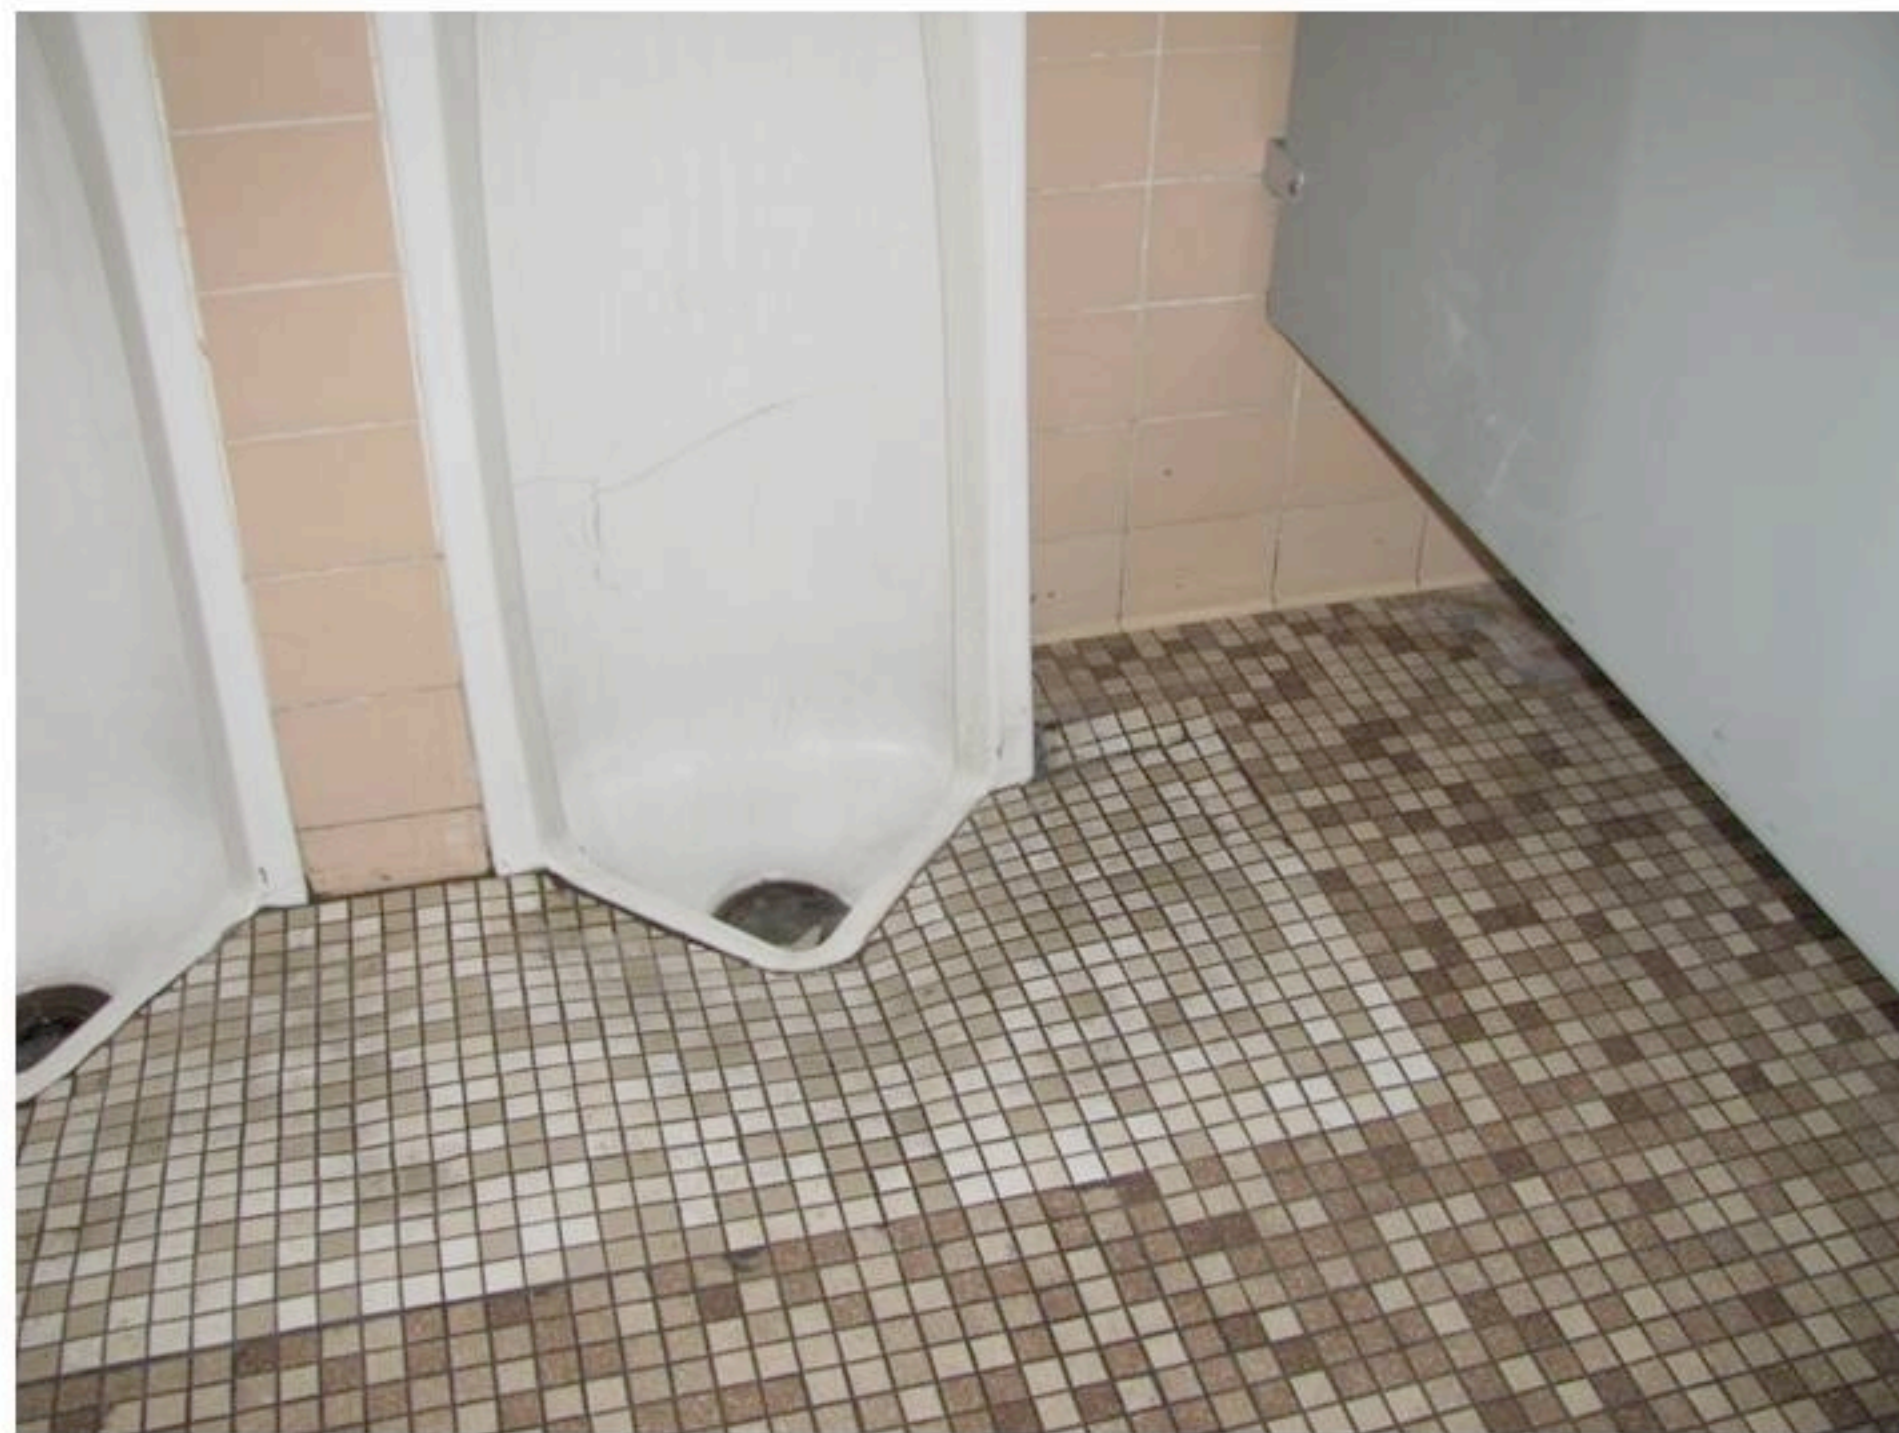
Another Urinal in Boys Restroom. Crack in the urinal is another source of trapped odors. Floor patch indicates frequent problems with plumbing below the floor.
